MA 39 – VFA 2013-0044.01

Inspection Report

Plastic Spacers (DL40/200 Rebar Spacers)

Client: Nevoga GmbH

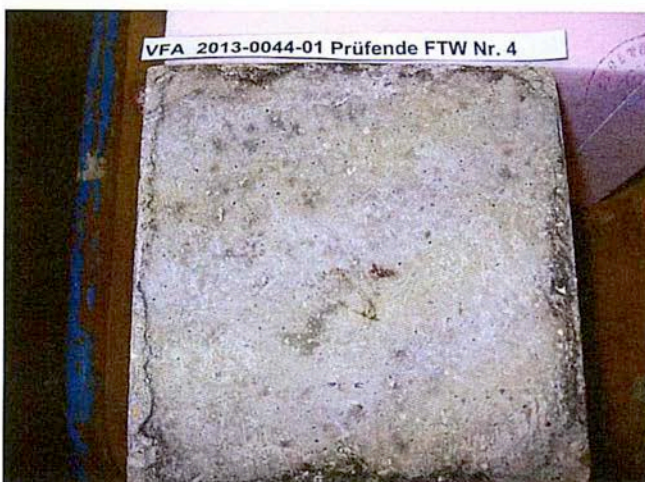
Photo No. 2013-0044-01-3

No cracking of any kind was determined, only a slight amount of flaking.

Freeze/thaw cycle testing

Sample 4 – after 56
freeze/thaw cycles

Slight flaking of the surface
can be determined, no
cracking.

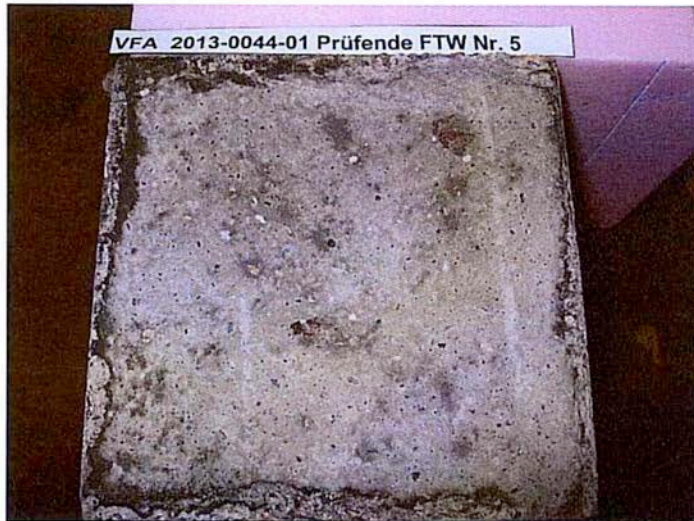
Photo No. 2013-0044-01-4

Freeze/thaw cycle testing

Sample 5 – after 56
freeze/thaw cycles

Slight flaking of the surface
can be determined, no
cracking.

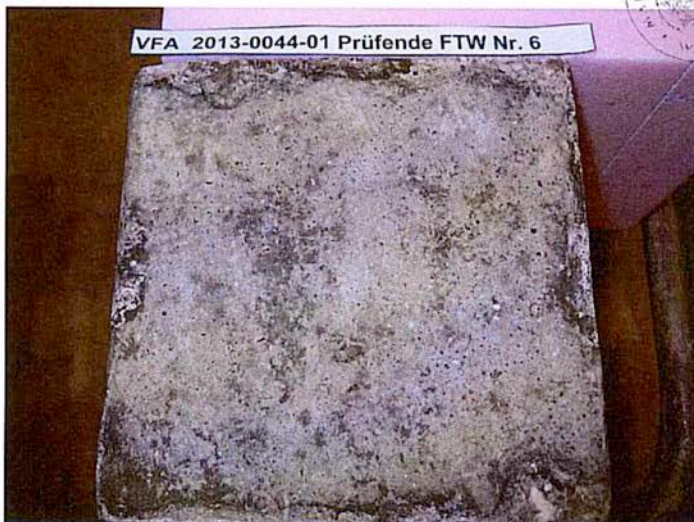
Photo No. 2013-0044-01-5

Freeze/thaw cycle testing

Sample 6 – after 56
freeze/thaw cycles

Slight flaking of the surface
can be determined, no
cracking.

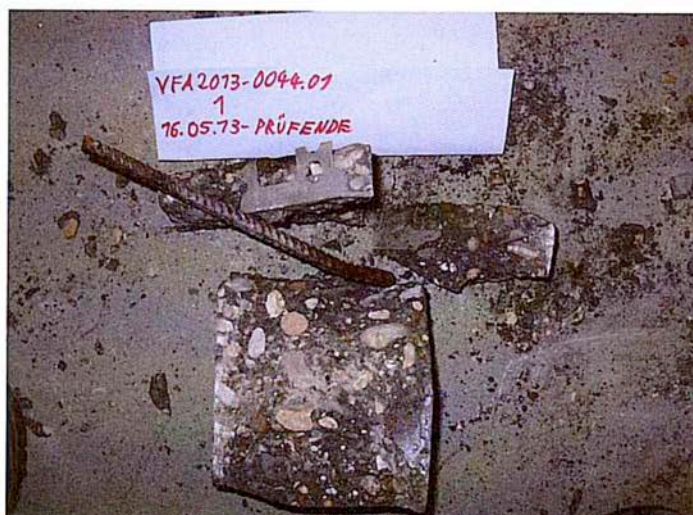
Photo No. 2013-0044-01-6

In samples 1 and 3, water penetration was visible up to the reinforcement bar.

Test of water penetration
depth

Sample No. 1 –
Water penetration depth: 40
mm
(up to the reinforcement bar)

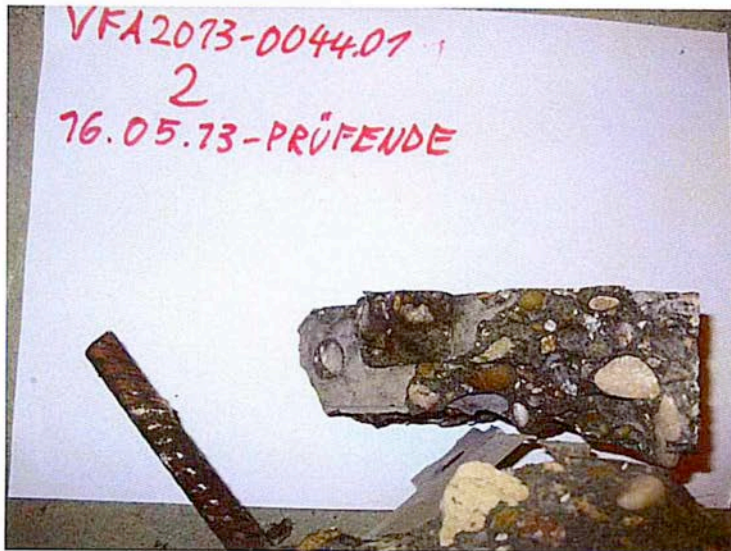
Photo No. 2013-0044-01-7

Test of water penetration depth

Sample No. 2 –
Water penetration depth: 14 mm
