MA 39 – VFA 2013-0044.02

Inspection Report

Plastic Spacers (R40 Circular Spacers)

Client: Nevoga GmbH

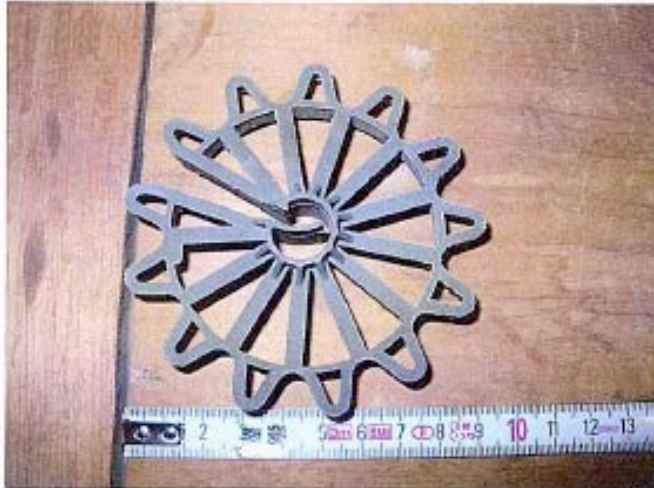
Photo No. 2013-0044-02-1

Plastic spacer (R40
Circular Spacer)

Condition upon delivery

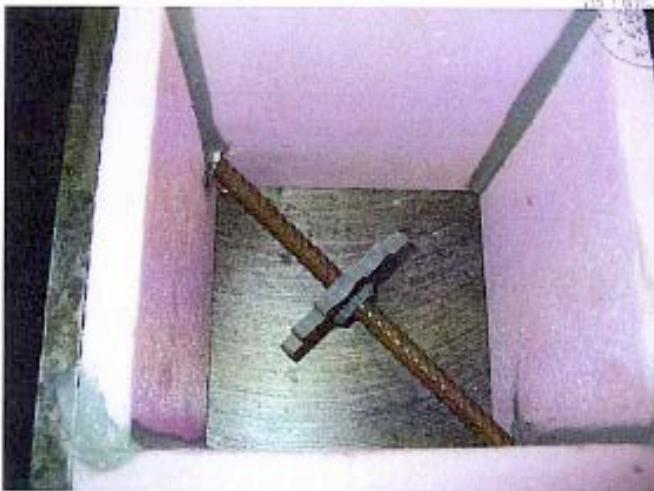
Photo No. 2013-0044-02-2

In deviation to the leaflet, polystyrene sheets were used in the cube moulds in place of plywood panels, and a reinforcement rod with a diameter of 8 mm with a spacer was placed inside (see Fig. No. 2013-0044-02-2).

Cube mould with
reinforcement rod and
spacer placed inside

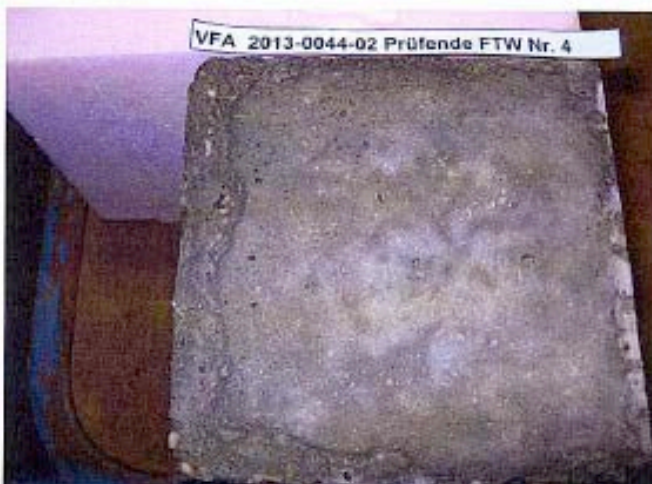
Photo No. 2013-0044-02-3

No cracking of any kind was determined, only a slight amount of flaking.

Freeze/thaw cycle testing

Sample 4 – after 56
freeze/thaw cycles

Slight flaking of the surface
can be determined, no
cracking.

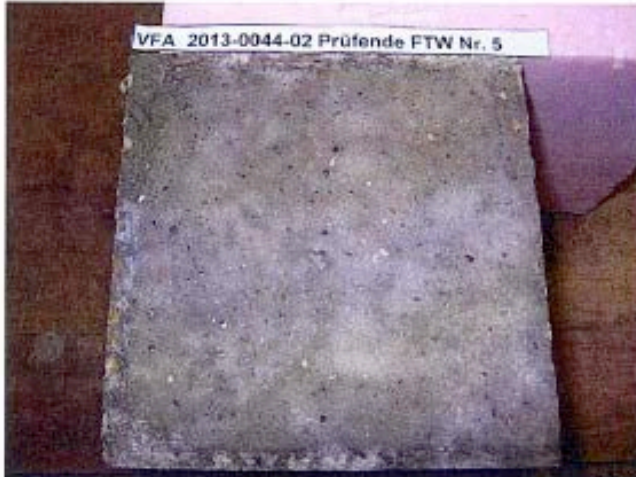
Photo No. 2013-0044-02-4

Freeze/thaw cycle testing

Sample 5 – after 56
freeze/thaw cycles

Slight flaking of the surface
can be determined, no
cracking.

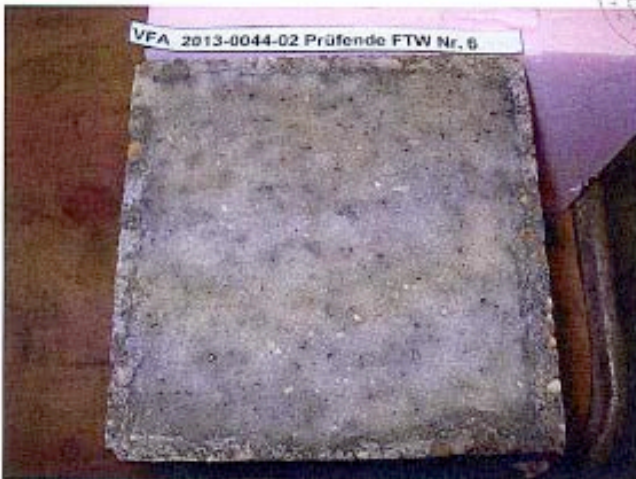
Photo No. 2013-0044-02-5

Freeze/thaw cycle testing

Sample 6 – after 56
freeze/thaw cycles

Slight flaking of the surface
can be determined, no
cracking.

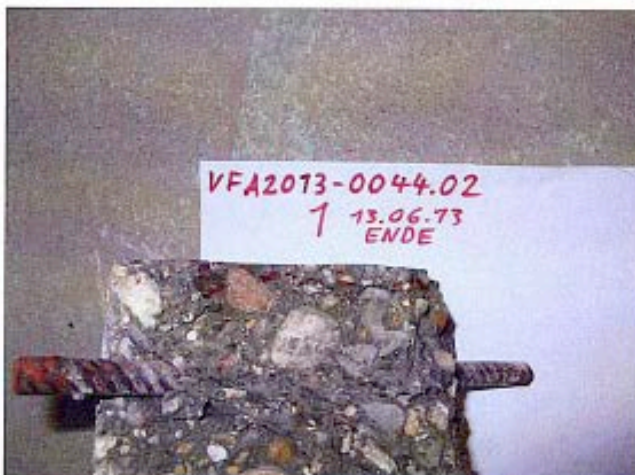
Photo No. 2013-0044-02-6

After splitting the test objects, a water penetration depth of between 17 mm and 20 mm was determined.

Test of water penetration
depth

Sample No. 1 –
Water penetration depth: 17
mm

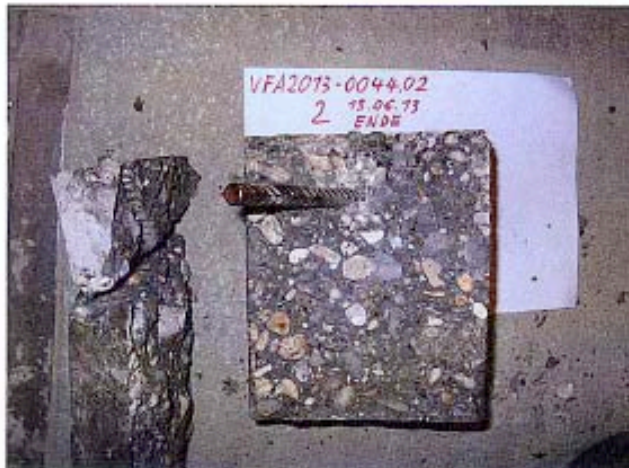
Photo No. 2013-0044-02-7

Test of water penetration depth

Sample No. 2 –
Water penetration depth: 18 mm

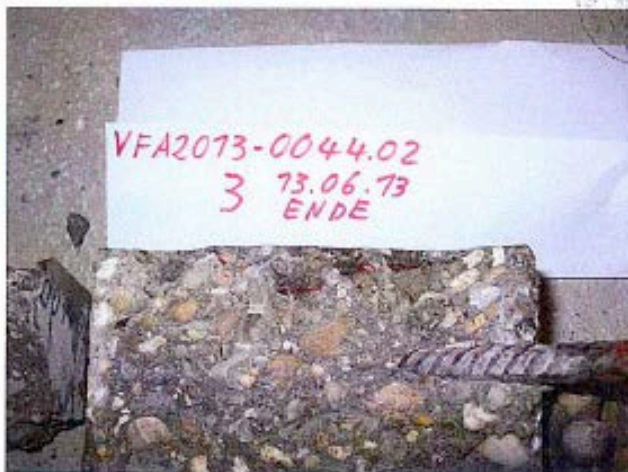
Photo No. 2013-0044-02-8

Test of water penetration depth

Sample No. 3 –
Water penetration depth: 20 mm

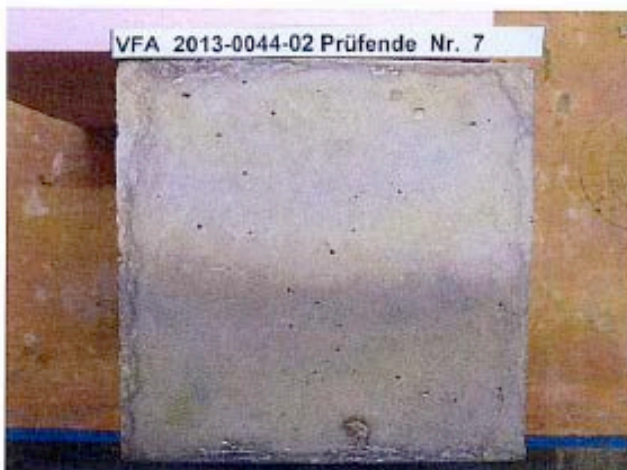
Photo No. 2013-0044-02-9

No flaking or cracking of any kind could be determined in the vicinity of the test surfaces.

Thermal cycling stress test

Sample 7 – after 10 cycles

No flaking or cracking of the surface determined

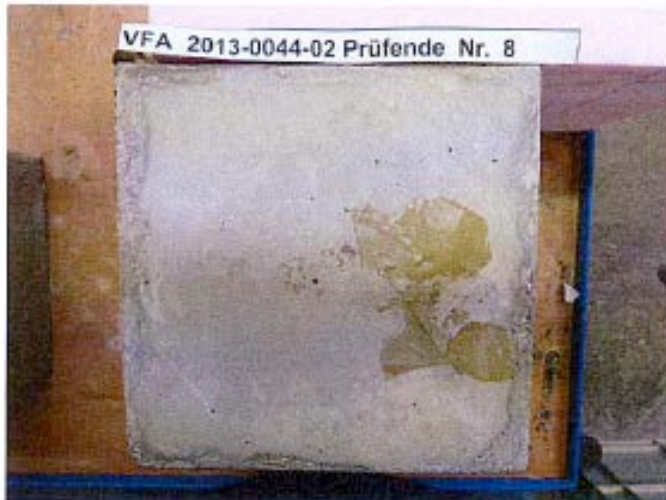
Photo No. 2013-0044-02-10

Thermal cycling stress test

Sample 8 – after 10 cycles

No flaking or cracking of the surface determined

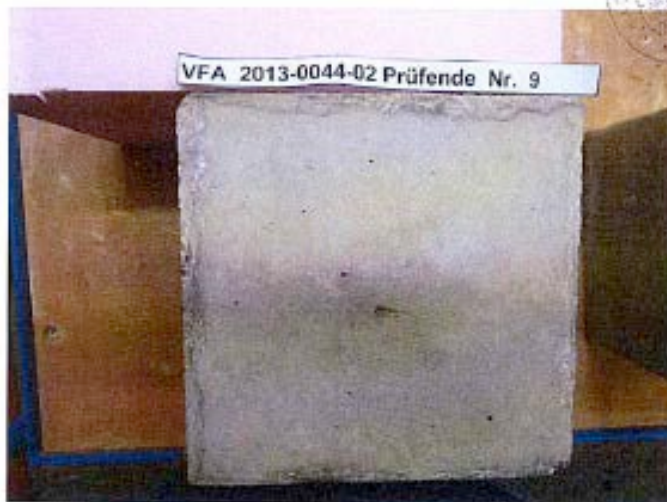
Photo No. 2013-0044-02-11

Thermal cycling stress test

Sample 9 – after 10 cycles

No flaking or cracking of the surface determined
